Project No.
007764/005311

Date
September 2012

ST AMBROSE HIGH SCHOOL & DRUMPARK ASN

ENVIRONMENTAL & REMEDICATION VALIDATION REPORT

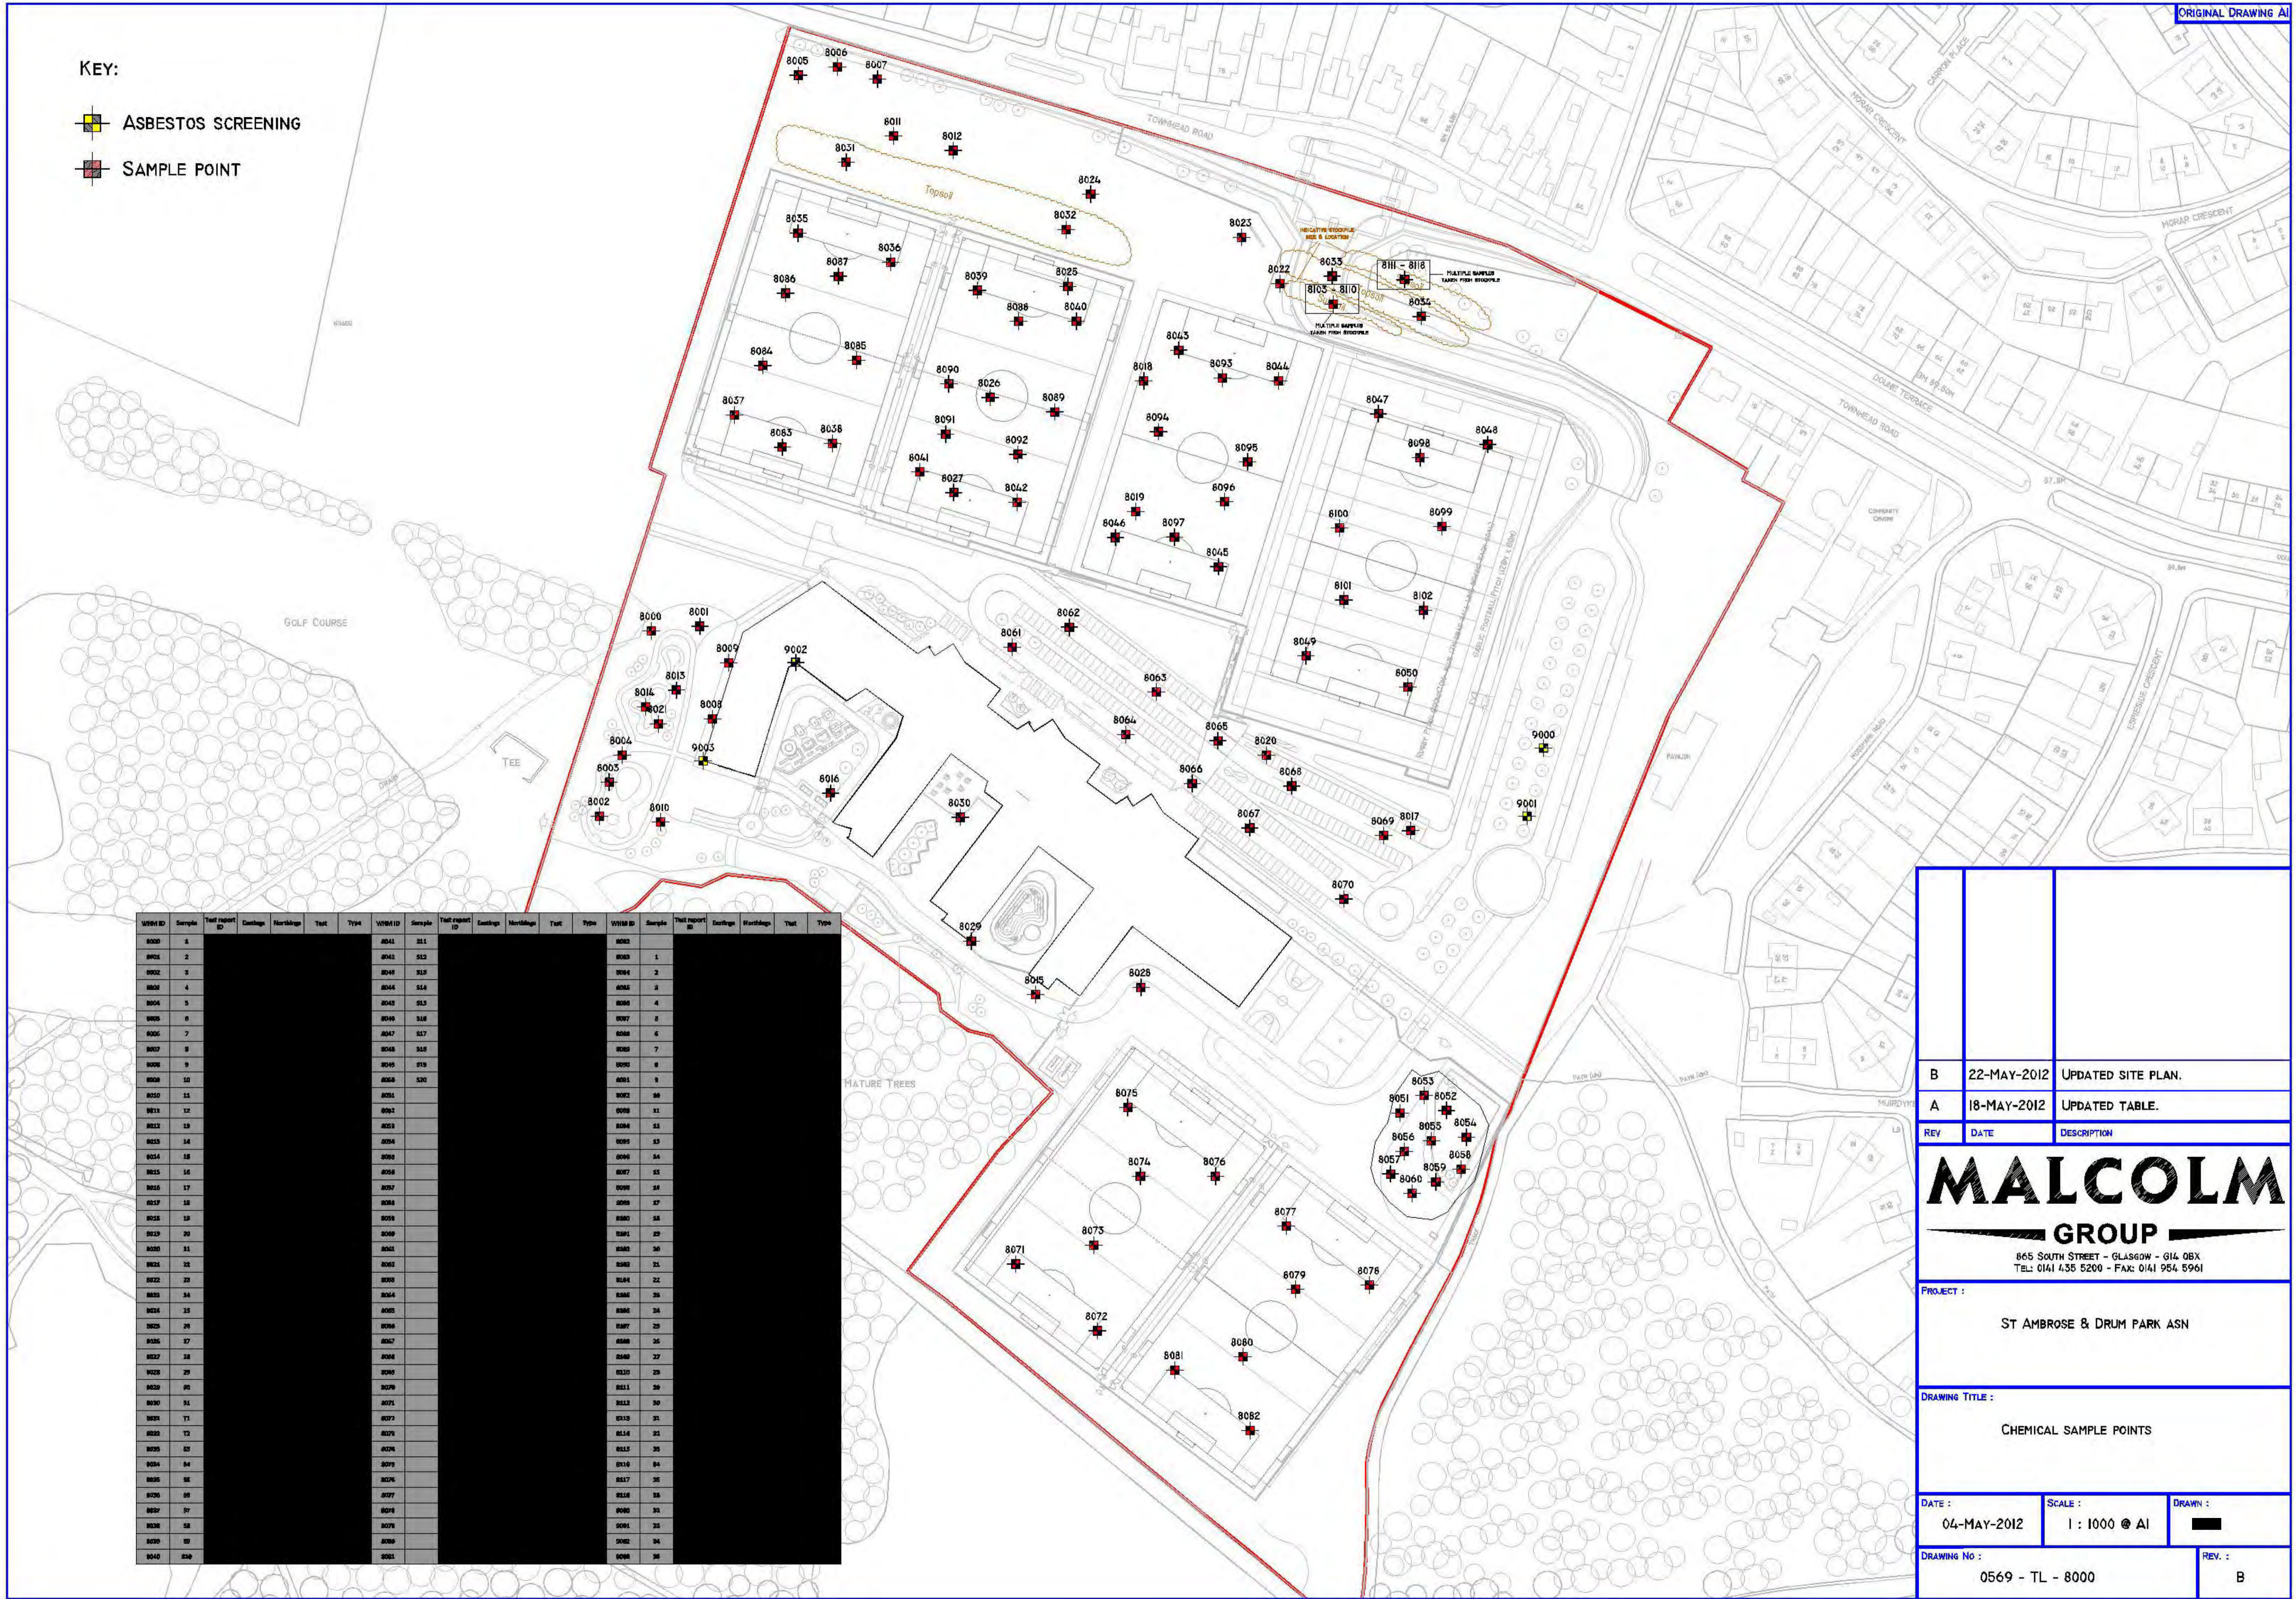
A total of 9No. samples were obtained from the cut material across pitch 6 (refer to Drawing 0569-TL-800, *Chemical Sample Points*) and of these 9No. samples, 2No. reported concentrations of lead slightly above the GAC (540mg/kg, 550mg/kg). However, statistical analysis of these 9No. samples (in accordance with CIEH guidance (2008)) indicates a 95%UCL of 430mg/kg, below the recommended GAC of 450mg/kg (see Table 4-1 below) therefore is not considered to present a significant risk to Human Health.
